IDR Sheet	1	of	1	Sheets	Final Record Book	Page
Contract		Day			Date	
C-7852		Tuesday			October 5, 2010

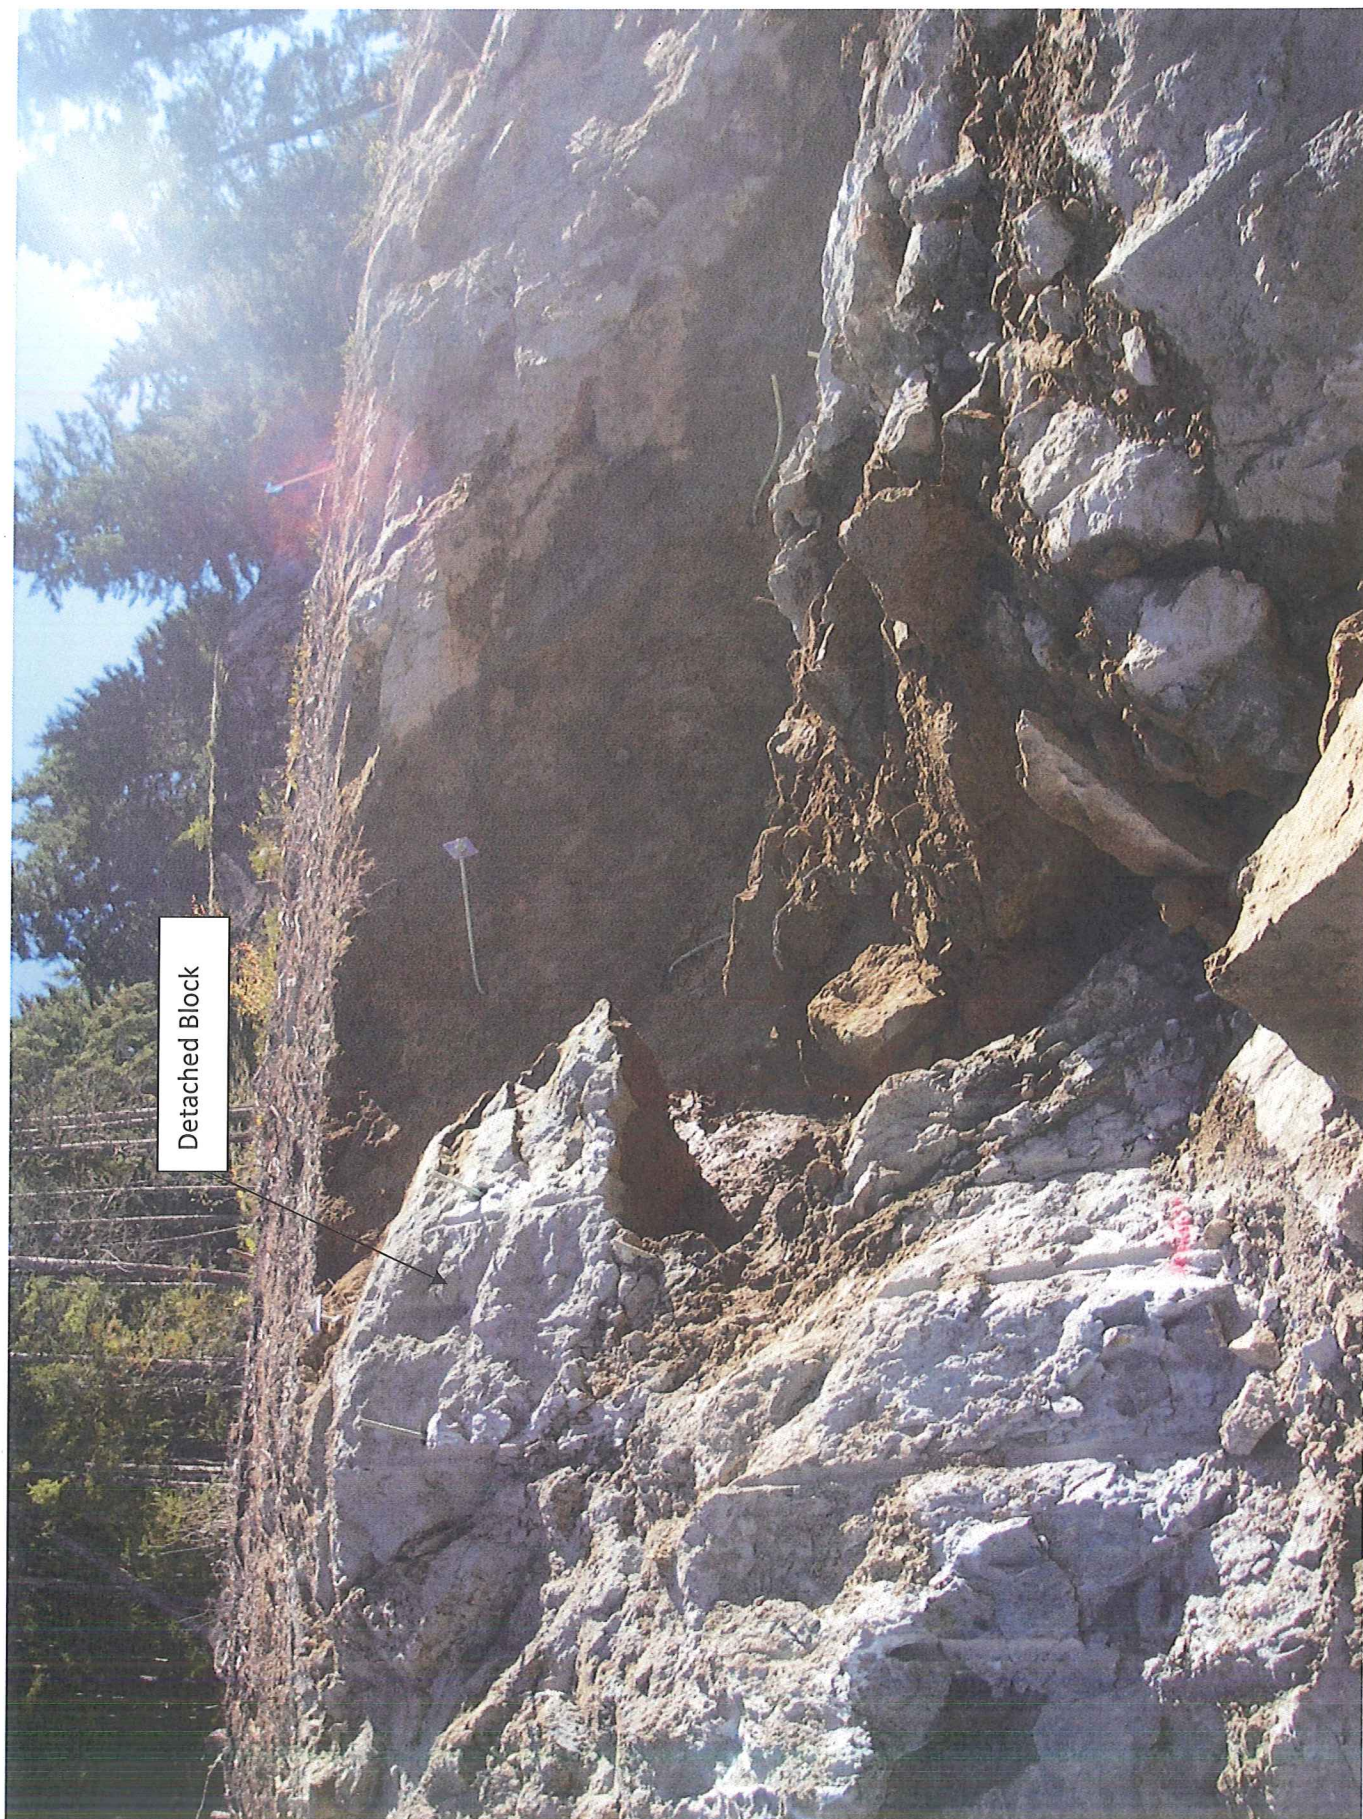
Norm, Brad, and I began a walk-through of the project from the east to the west end of the project. During our walk-through, Brad received a call about a failure that occurred at approximate station 1327+00 (Figure 1). This is the location of the detached blocks that were recommended to be scaled in the IDR dated 10/4/2010. A detached block remained on the slope so Norm, Brad and I recommended the contractor attempt to mechanically scale (remove) the block with little to no damage to the installed rock dowels. Brad and I got our climbing gear on to assess the slope above the failed area. Brad and I did not observe any instabilities upslope and it appeared that the recent rockfall failed to a competent backslope. Brad and I had the operator slope round the crest of the slope to a more stable configuration (Figure 2).

Figure 1. A photograph of the recent rockfall location at approximately station 1327+00. Note the detached block that remained on the slope.

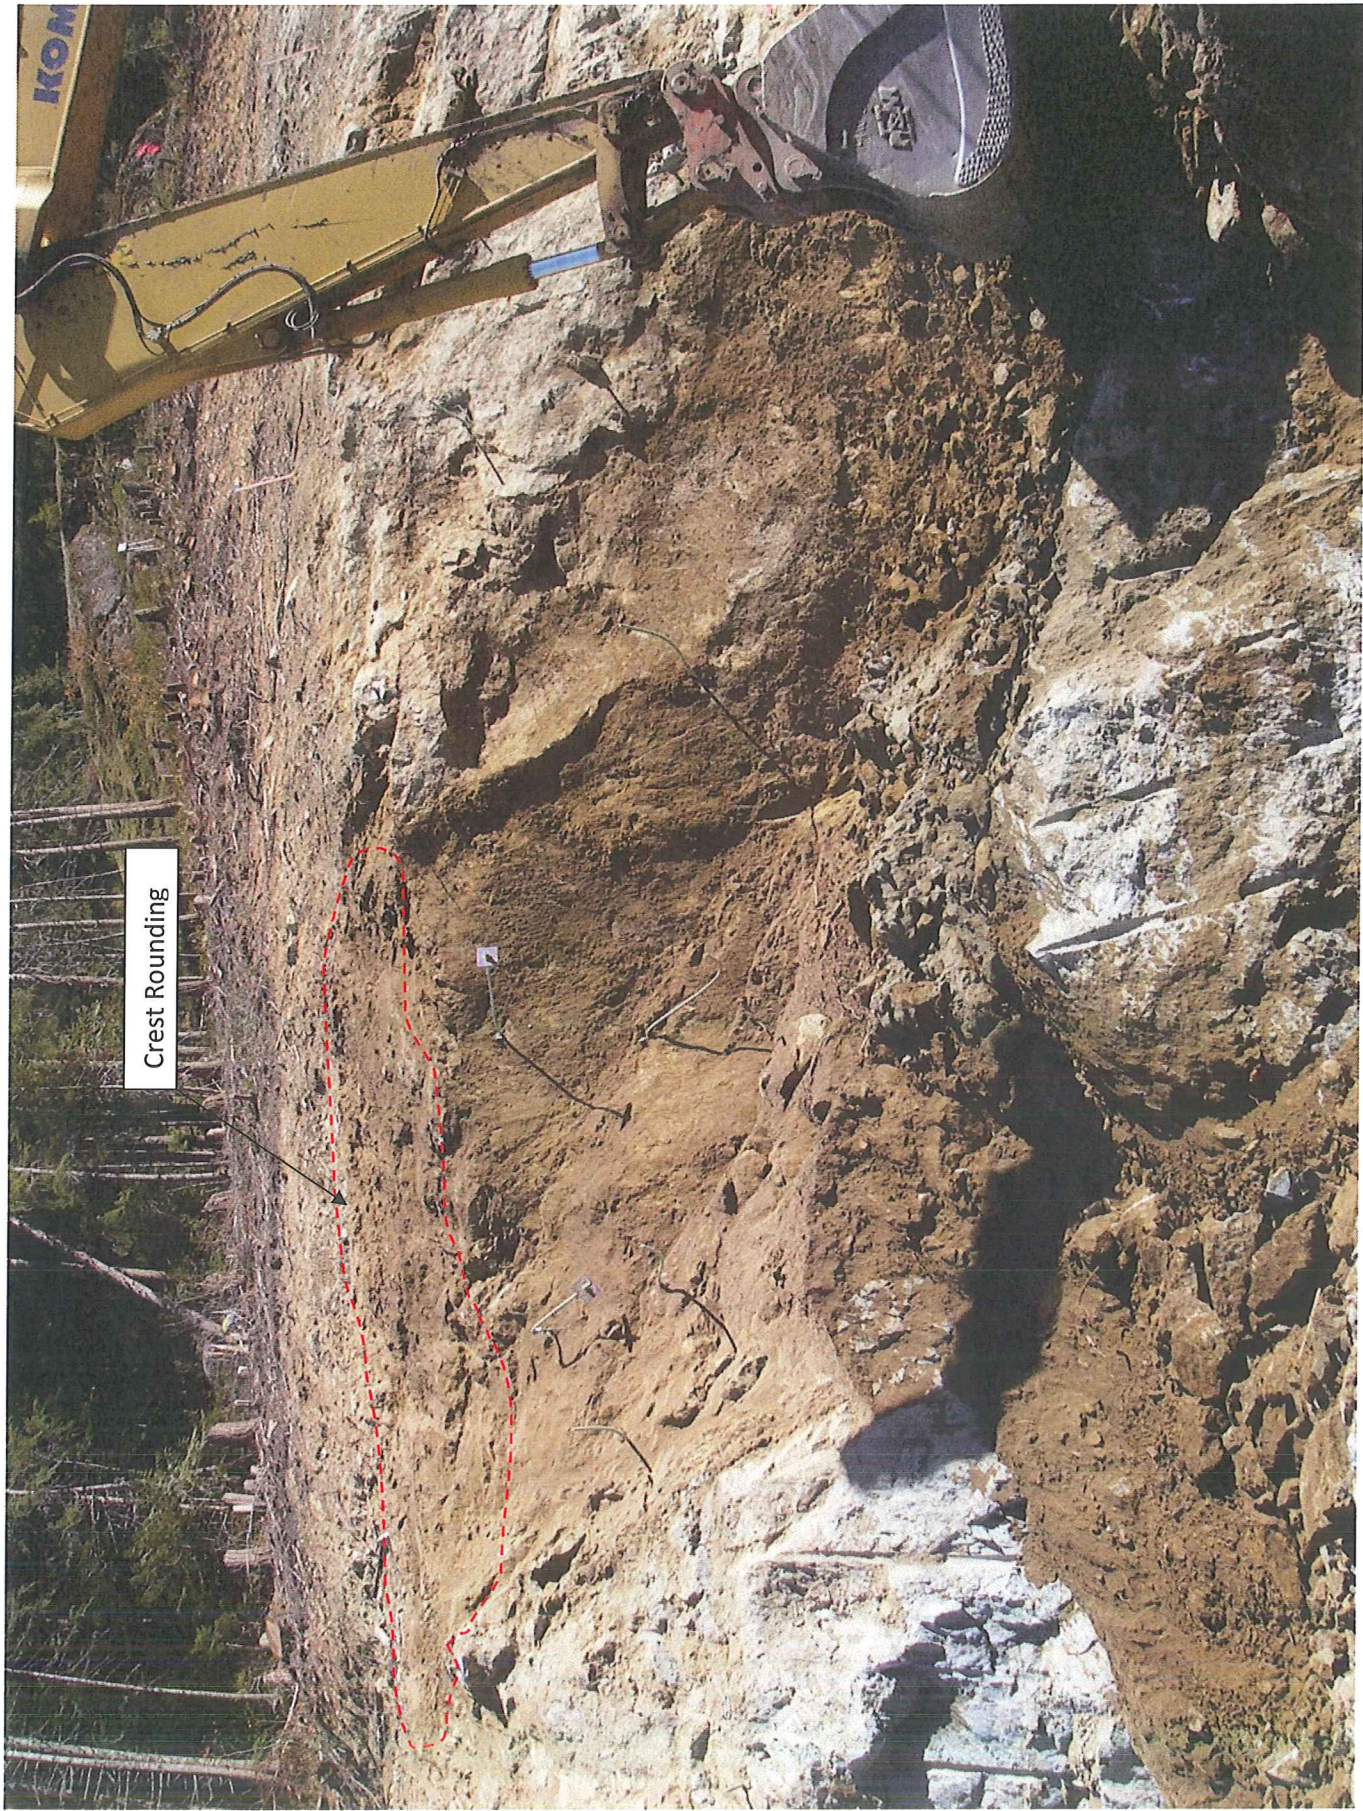
Figure 2. A photograph showing that the recent rockfall failed back to a more stable backslope. Note the slope rounding that occurred at the crest of the slope (red dashed line).

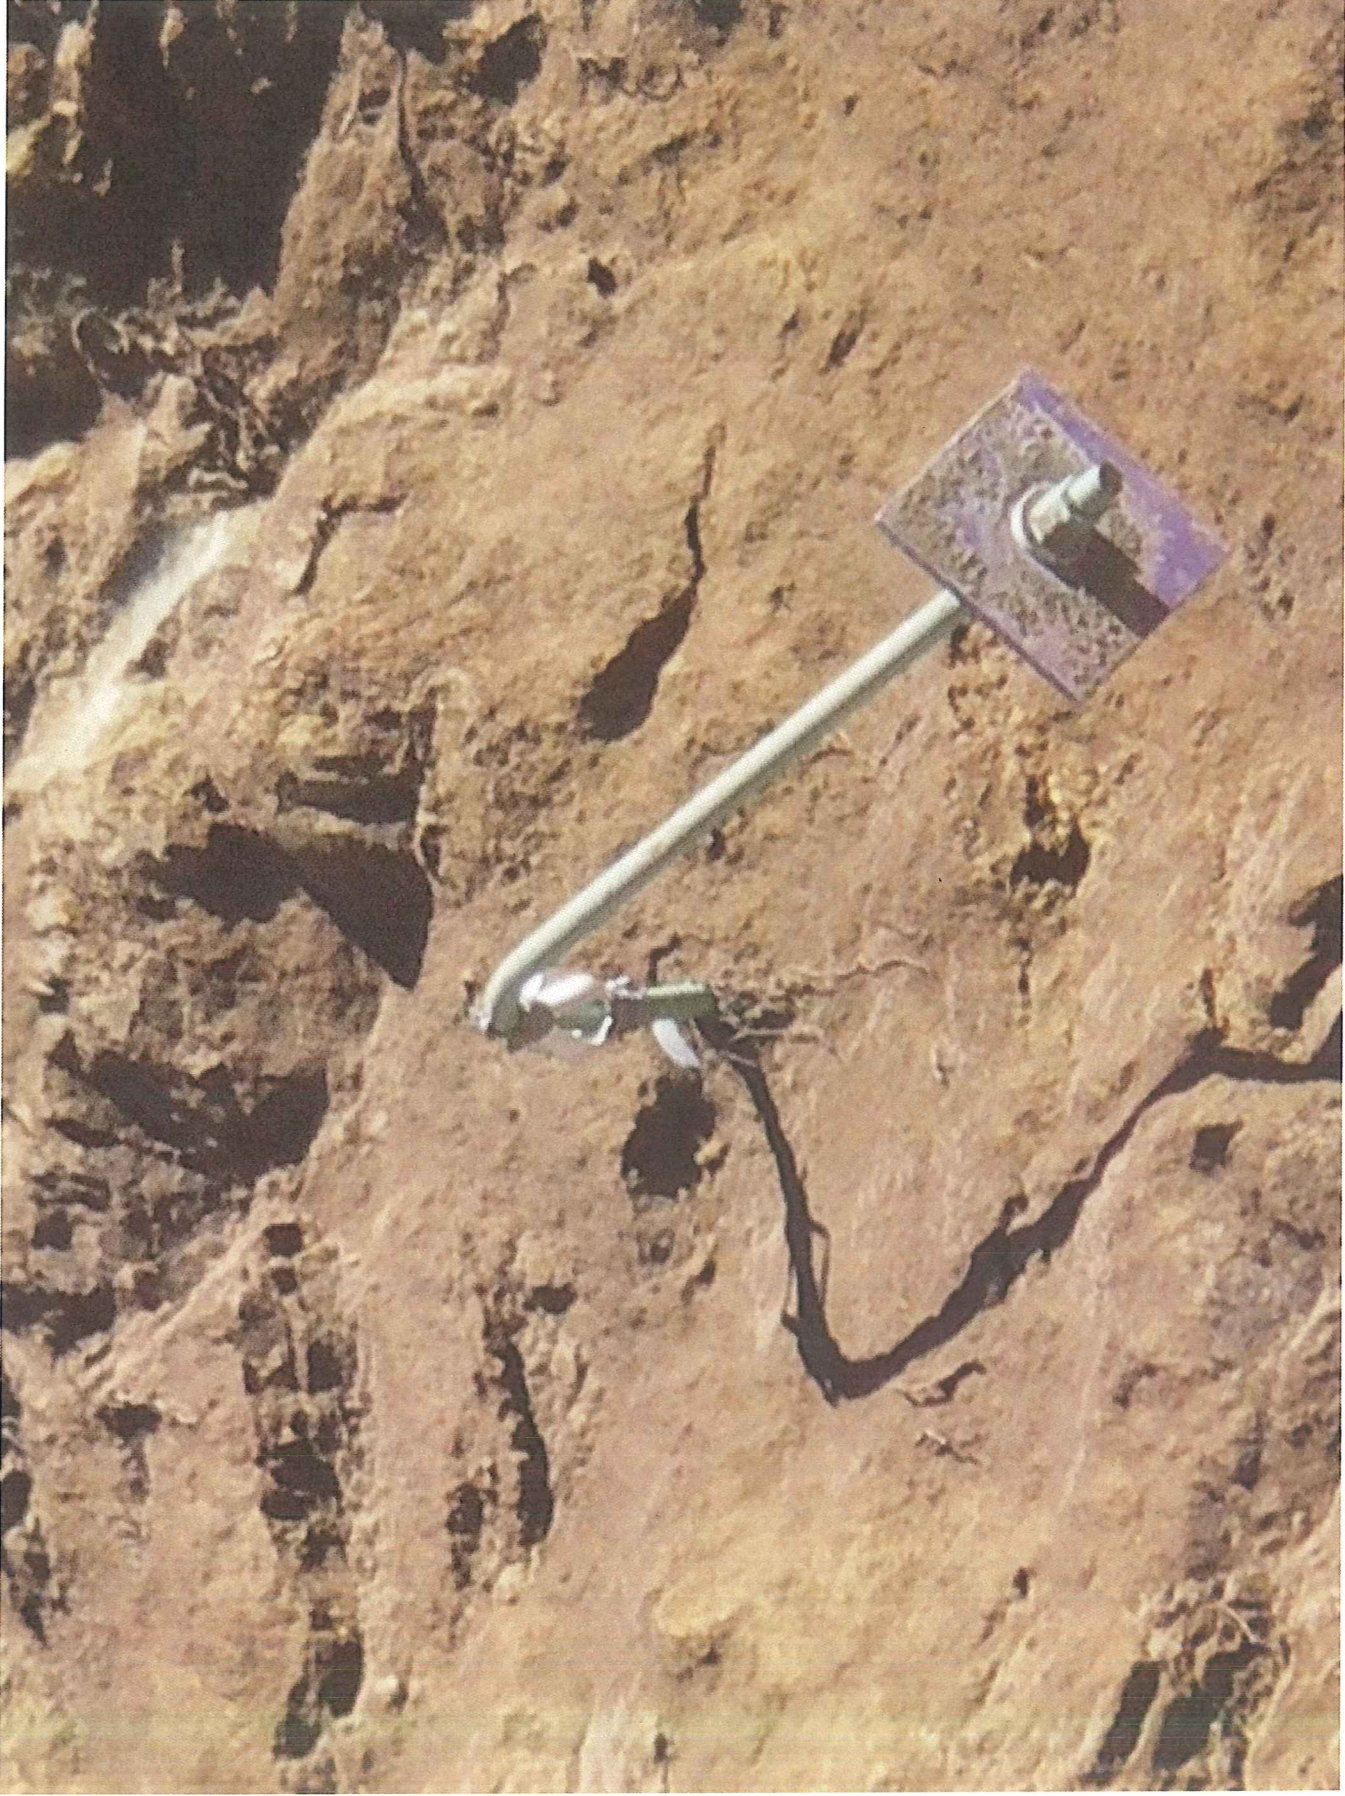
While we were on-site, we observed that the previously installed dowel bars did not have any grout remnants on them and numerous plates and nuts were never installed (Figure 3). It also appears that the secondary grouting did not take place in many of these dowels and this may have contributed to the recent rock failure. With this in mind, I walked the entire project limits and counted all the rock anchors that did not have plates and nuts. I counted 111 rock anchors and this did not include the recent rockfall location or the dowel bars that were installed within the past couple of days. I am also assuming that none of these 111 rock anchors had the secondary grout placed. Brad indicated that the plates just arrived on-site recently and the contractor was going to begin working evenings to get the plates and nuts installed and place the secondary grout.

Figure 3. A photograph showing one of the rock dowels that was previously installed in one of the failed blocks. Note that there does not appear to be any grout on the bar or the centralizer.

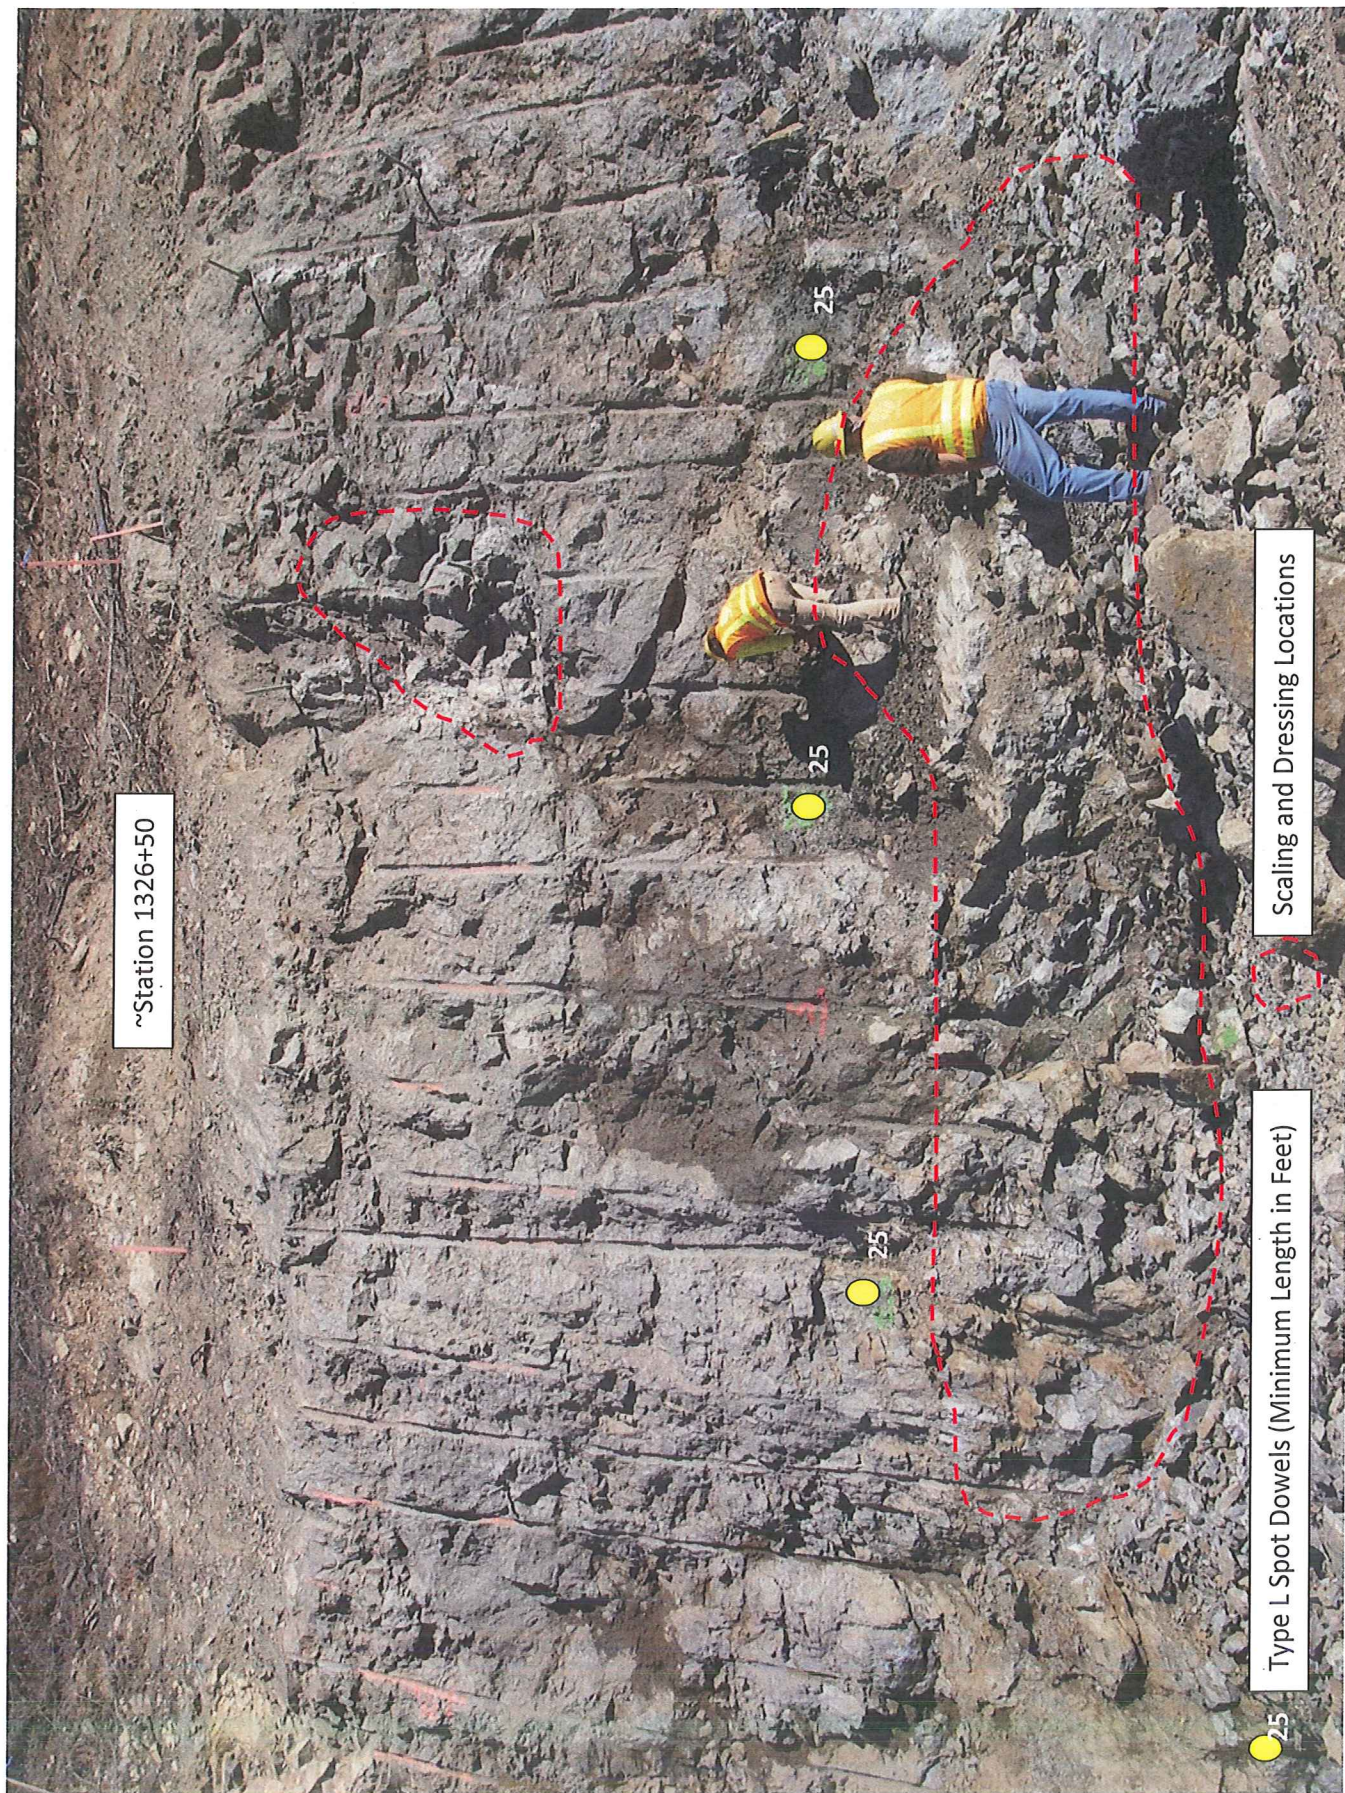
Brad, Rocki and I located three rock dowels at approximate station 1326+50 (Figure 4). While we located these dowels, we all observed that this area needed additional scaling and dressing to be performed.

Figure 4. A photograph showing the lift inspection at approximate station 1326+50.
